Products: VC520 Pro / Expansion Speakerphone

VC520 Pro Firmware Version: v0.0.1004.32

VC520 Pro expansion speakerphone: v0.0.8000.10

Published Date: August 31, 2020

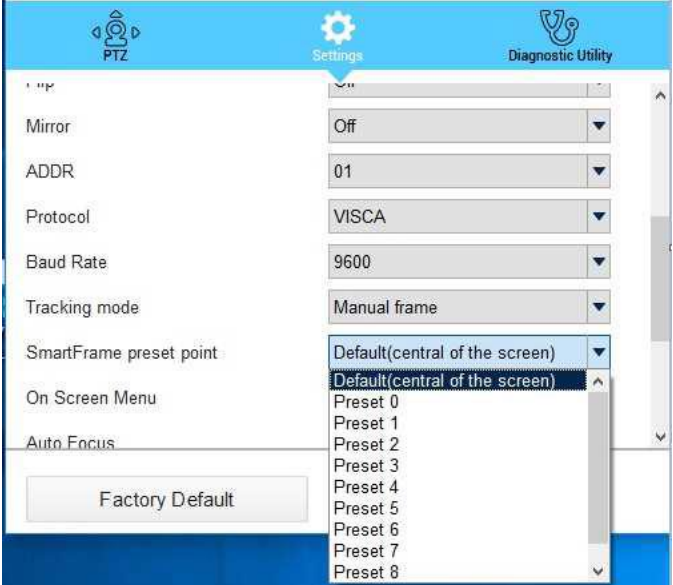
<p>The screenshot shows the PTZApp Settings menu. The 'SmartFrame preset point' dropdown is open, showing 'Default(central of the screen)' as the selected option. Other options include Preset 0 through Preset 8. A 'Factory Default' button is visible at the bottom of the settings panel.</p> <p>PTZApp should be upgraded to v. 1.4.1087.90 (MAC); v. 1.4.1112.116 (Windows) to get full functions</p> <ol style="list-style-type: none"> IP webpage: H.264 Profile setting adds two options: H.264 Baseline Profile/ High Profile VISCA command adds power on/ off

Firmware Version	New Features
0.0.1004.30	<ol style="list-style-type: none"> Image settings: Original: When unplugging adaptor or rebooting, the image settings and WDR will be set back to default value. New: All the image settings and WDR will be retained after unplugging adaptor or rebooting. Add SmartFrame preset point function. Original: Camera always goes back to central position to capture all participants and zoom in. New: Users can choose the preferred preset point direction and camera will capture all participants based on the appointed preset point.
